A Field Observation on Lightning Performance Improvement of Overhead Distribution Lines

Abstract. Two feeders of 20 kV overhead distribution lines which are located in a high lightning density area are chosen to be observed as a field study due to their good lightning performance after improvement of lightning protection system. These two feeders used the new overhead ground wire and new line arrester equipped with lightning counter on the main lines. The significant reduced of lines outages are reported. Study was carried out to observe these improvements by comparing to the other two feeders line which are not improved and not equipped yet with the ground wire and line arrester. These two feeders located in the nearby area. Two cameras were installed to record the trajectory of the lightning strikes on the improved lines. Lightning peak currents are measured using magnetic tape measurement system installed on the grounding lead of lightning arrester. Lightning overvoltage calculations are carried out by using several scenarios based on observation results and historical lightning data derived from lightning detection network. Lightning overvoltages caused by indirect or direct s

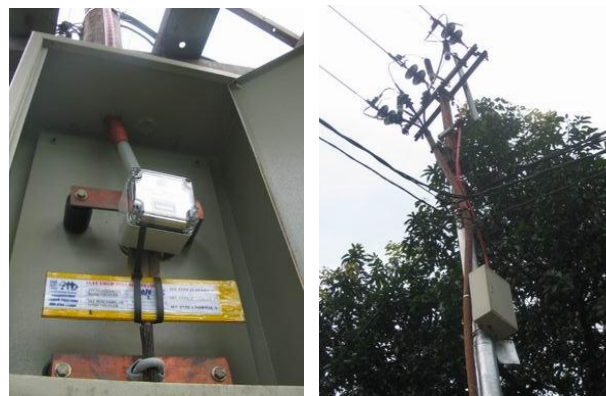
Figure 11 Magnetic tape measuring system and lightning event counter installation on arrester grounding lead.

A peak current measurement system using magnetic tape (APM) consist of three different type of commercial magnetic tape which are IEC type I Normal, type II Chorm and type IV Ferro. These tapes were filled with 315 Hz sinusoidal signal and laid on yellow fiber plate and attached to the arrester grounding lead [1].

The measurement unit installed in several pole with different type of arrester installation such as ; arrester lead on distribution transformer, arrester lead on the line and arrester lead on cable at dead end tower. The magnetic tape measurement system (APM) and lightning event counter (LEC) are placed in a box attached to the tower. Minimum current of 2 kA can trigger the LEC. The lead grounding of arrester is using single core N2XS/Y 1x50 mm² cable to allow lightning current flows undisturbed to the ground through the LEC and APM.
